Modes Indicate Cracks in Wind Turbine Blades

ABSTRACT

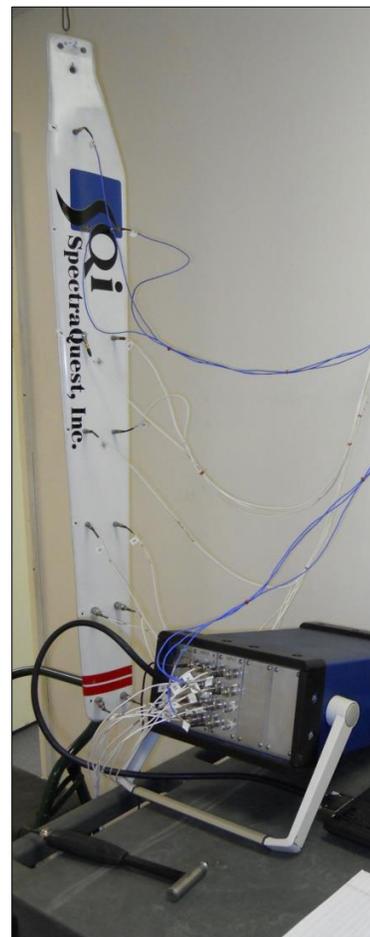
Figure 1 Blade Test Setup.

The blade test setup is shown in Figure 1 below. Thirteen accelerometers were attached to the surface of the blade, and it was impacted with an instrumented hammer at each end and in the middle. The accelerometer locations are labeled in Figure 2.

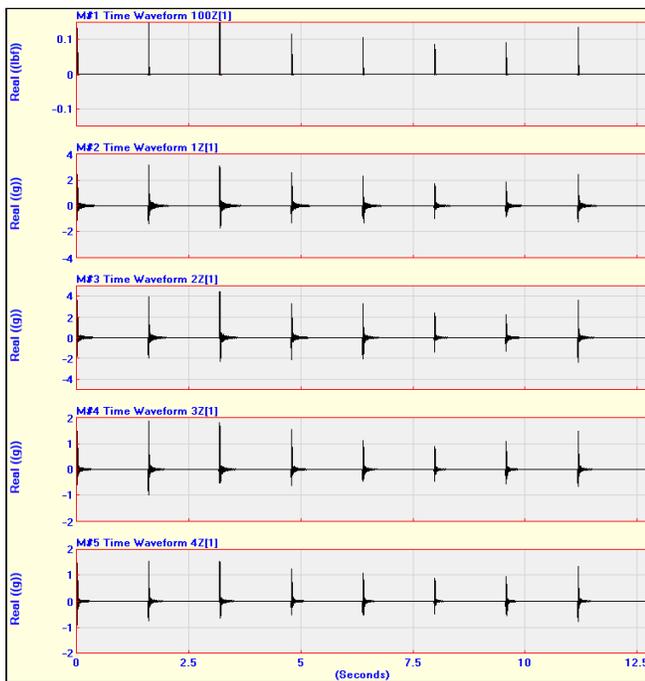
Figure 3 Typical Time Domain Records.

During impact testing, time domain records of 64000 samples each were acquired from the impact hammer and 13 accelerometers. Each record contained data from 8 consecutive impacts. Three sets of data were taken by impacting in the middle and at each end of the blade. A typical set of the acquired time records (1 impact and 4 responses) is shown in Figure 3.

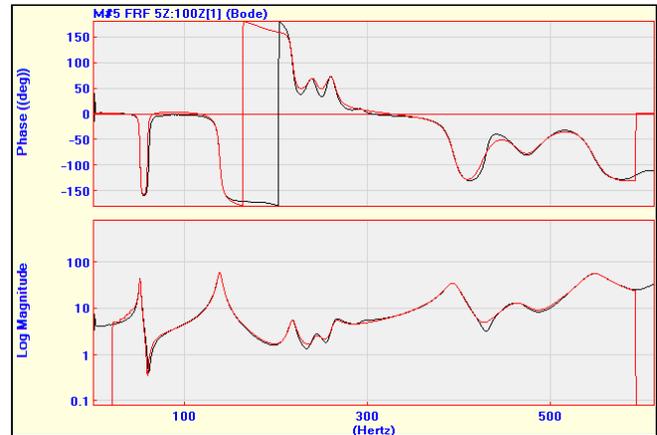
Figure 4 Typical FRF and Fit Function Overlaid.

The acquired time records were post-processed using tri-spectrum averaging (8 averages), with a pre-trigger delay to capture each impact signal and its corresponding responses. FRFs were then calculated from the Auto and Cross spectra. A typical FRF is shown in Figure 4. Each FRF contained 4000 samples of data, over a frequency span (0 to 2563.5 Hz) with frequency resolution of 0.64 Hz. The impact force Auto spectrum dropped off substantially above 800 Hz, so data was only used over the span (0 to 800 Hz).

Modal parameters (frequency, damping, mode shape) were obtained by *curve fitting* each set of FRFs. A **red curve fit** function is shown overlaid on the FRF data in Figure 4.

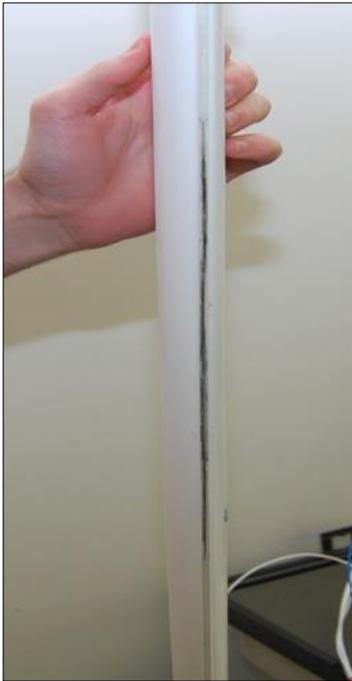
Figure 5 Edge Crack

The first kind of induced blade failure was a series of cracks along one edge of the blade, as shown in Figure 5. Four modal tests were performed so that the modal parameters of the blade with no crack could be compared to the parameters of the blade with edge cracks;

- Test 1: No edge crack
- Test 2: 5 inch edge crack
- Test 3: 10 inch edge crack
- Test 4: 20 inch edge crack

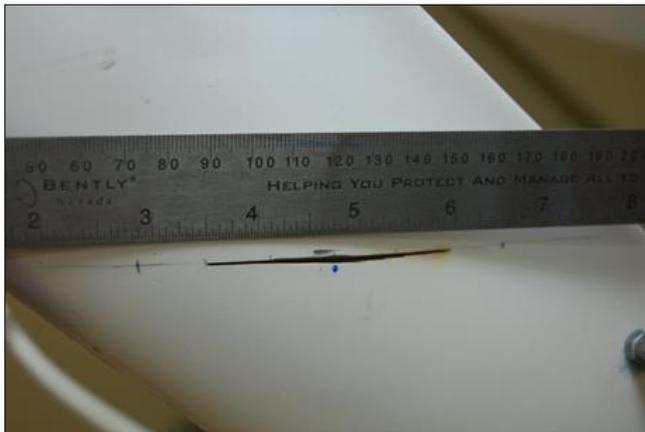
Figure 6 Surface Crack

Following the first four tests, the blade was epoxy'd back together, and a second series of cracks were induced in the surface of the blade. A surface crack is shown in Figure 6. Four more modal tests were performed so that the modal parameters of the blade with no crack could be compared to the parameters of the blade with surface cracks;

- Test 5: No surface crack
- Test 6: 1.3 inch surface crack
- Test 7: 2.6 inch surface crack
- Test 8: 3.9 inch surface crack

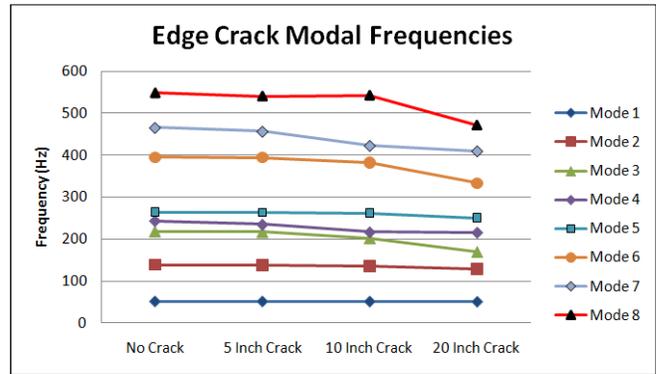
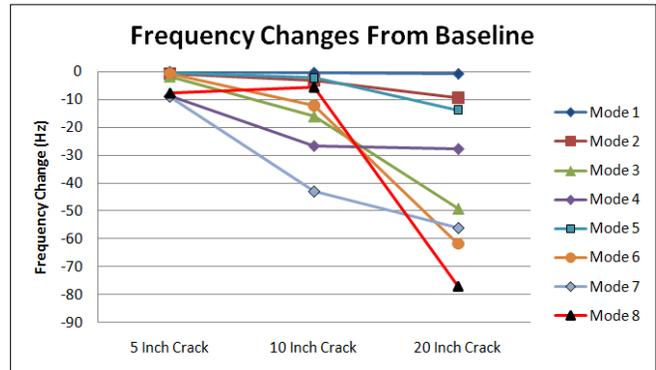
Figure 7

The modal frequencies obtained from the four edge crack tests are plotted in Figure 7. As expected, the frequencies trend downward with increased severity of the crack. This is because the edge cracks caused a decrease in the blade stiffness.

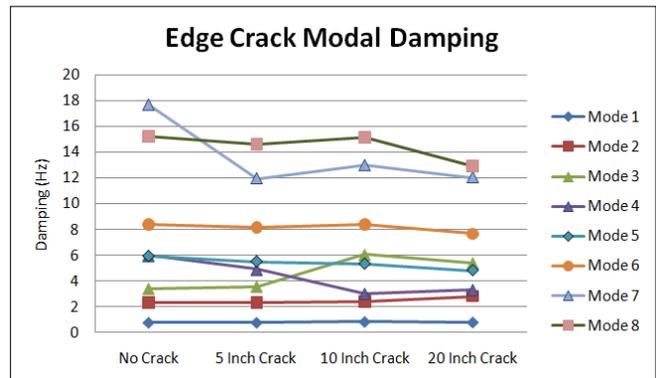
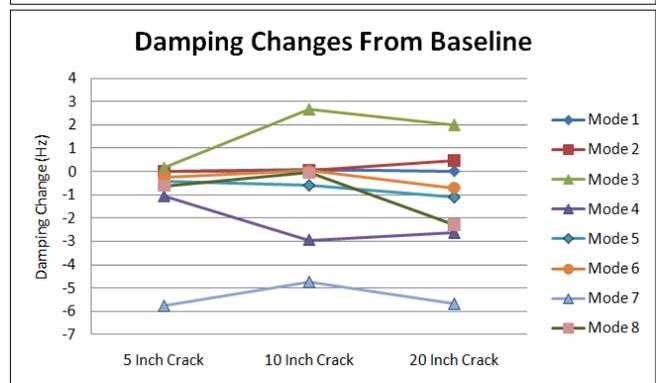
Figure 8

Modal damping for the four edge crack cases is shown in Figure 8. Most of the *damping changes from the baseline* are *negative*, except for modes 2 and 3 which are *positive*. A *negative change* means that the crack created *less damping* in the mode. A *positive change* means that the mode was *more heavily damped*.

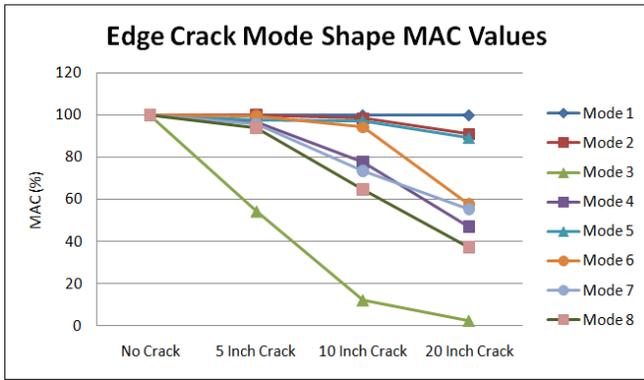
Figure 9

Mode shape MAC (Modal Assurance Criterion) [ref. 3] values for the four edge crack tests are shown in Figure 9. A MAC value of **100% indicates no change** in the mode shape.

The MAC values indicate **little significant change** due to the 5-inch crack, except for Mode 3. However, the 10-inch and 20-inch cracks caused **significant changes** in the mode shapes of several (but not all) modes.

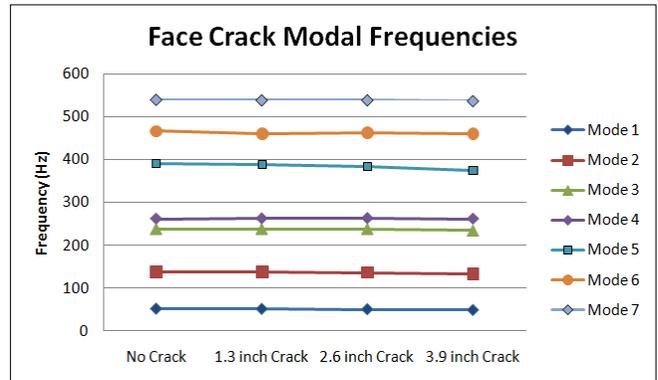
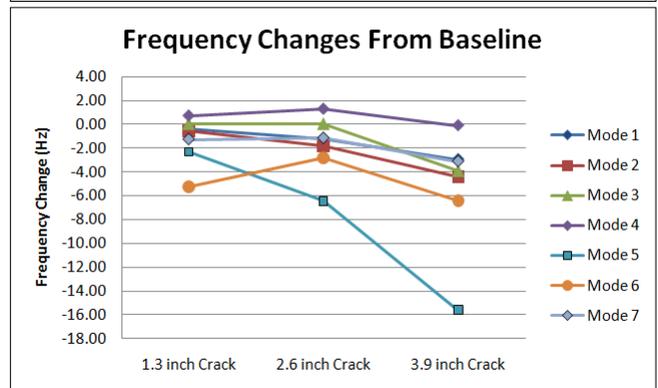
Figure 10

The modal frequencies obtained from the four surface crack tests are plotted in Figure 10. Most of the frequencies trend downward with increased crack severity, except Mode 4 which trended upward for the 2.6 inch crack. This upward trend was not expected.

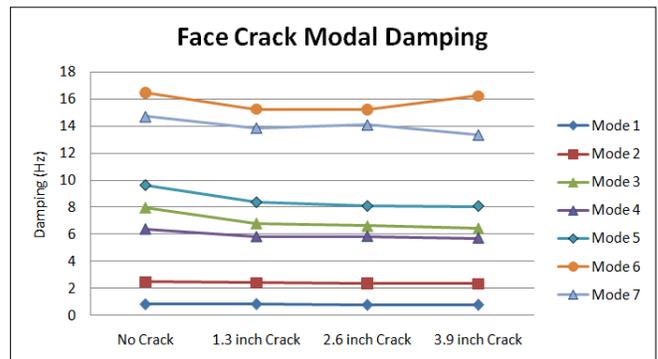
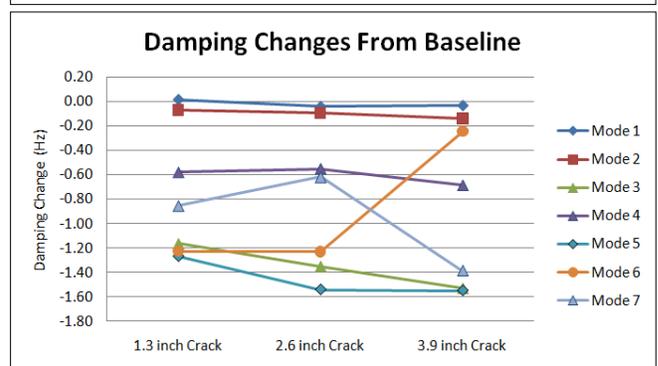
Figure 11

Modal damping for the four surface crack cases is shown in Figure 11. All of the damping changes from the baseline are negative, meaning that the surface cracks created **less damping** in the blade.

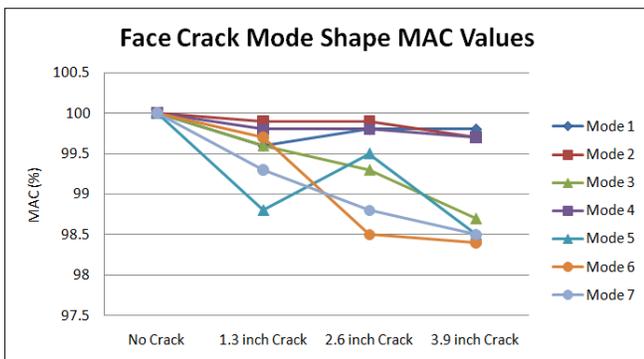
Figure 12

Mode shape MAC values for the four surface crack tests are shown in Figure 12. All MAC values are **above 98.4%**. This means that all three surface cracks caused **very little change** in the mode shapes.
